# Long Time Creep Rupture of Haynes<sup>TM</sup> Alloy 188

Robert L. Dreshfield  
*Lewis Research Center  
Cleveland, Ohio*

Prepared for the  
Eighth International Symposium on Superalloys  
sponsored by The Minerals, Metals, and Materials Society  
Champion, Pennsylvania, September 22–26, 1996

1. AGENCY USE ONLY (Leave blank)		2. REPORT DATE April 1996		3. REPORT TYPE AND DATES COVERED Technical Memorandum
4. TITLE AND SUBTITLE Long Time Creep Rupture of Haynes™ Alloy 188			5. FUNDING NUMBERS  WU-547-10-11

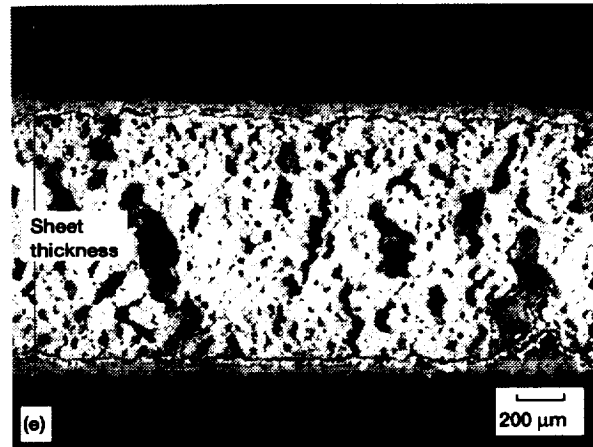
Figure 7.—Selected photomicrographs. (a) As received. (b) Transverse section 13441 h at 790 °C etched. (c) Transverse section 13441 h at 790 °C unetched. (d) Longitudinal section 22115 h, 845 °C unetched. (e) Longitudinal section 6186 h, 900 °C unetched. (f) Longitudinal section 22115 h, 845 °C etched.

The microstructure of the as-received material shown in Fig. 7(a) consists of a twinned cobalt-base matrix and dispersed particles which are assumed to be  $M_6C$  and lanthanides. The microstructures observed in this study are consistent with those reported by Herchenroeder.<sup>7</sup>

The structure after 13441 h at 790 °C and 103 MPa is shown in Figs. 7(b) and (c). The grain boundaries and prior twin boundaries are decorated with precipitates and the intergranular precipitates are coarsened. Oxide spikes originating at the sheet surface have penetrated to a depth of about 60  $\mu m$ .

After 22,115 h at 845 °C and 44 MPa the oxide spike penetration is about 100  $\mu m$ , Fig. 7(d). In addition, there are oxidized pores across the full thickness near the fracture. The presence of oxidized pores is even more pronounced in Fig. 7(e) which shows the structure of a specimen which failed after 6,186 h at 900 °C. It is probable that internal damage is responsible for the loss of tensile ductility observed in the interrupted creep specimens. The general structure after 22,115 h at 845 °C is

shown in Fig. 7(f). It resembles Fig. 7(b), but the precipitates are coarser as a result of the longer exposure at higher temperature.
